historic structure report  
architectural data section

FORT JEFFERSON

NATIONAL MONUMENT / FLORIDA

BY: LOUIS ANDERSON  
APRIL 1988

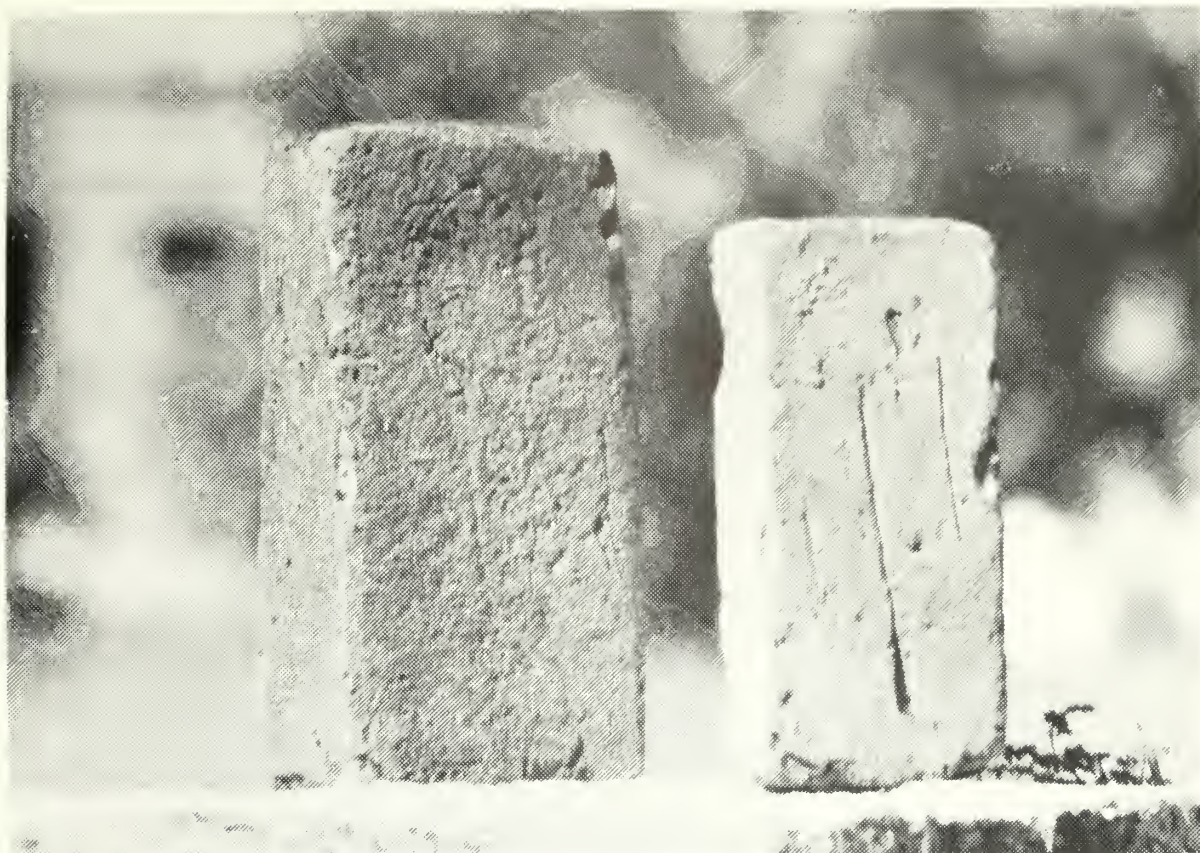
**Figure 3** PENSACOLA AND NORTHERN BRICK

brick.<sup>6</sup> With the wear associated with marine and climatic exposure, the edges of these brick have become rounded and the granular character of their constituent clay revealed.

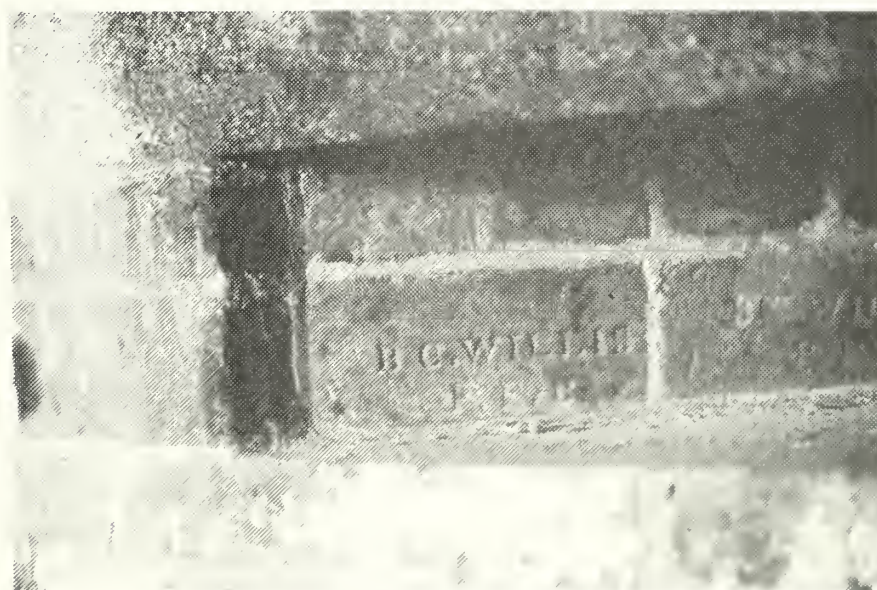
**Figure 4** STAMPED BRICK

Brick stamped "B.C. Willis" appear in the sides of the tongue hole lintels of the casemates. Several of the casemate vaults have stamped brick at the apex of the vault, also. (See Figure 4, Stamped Brick, previous page.)

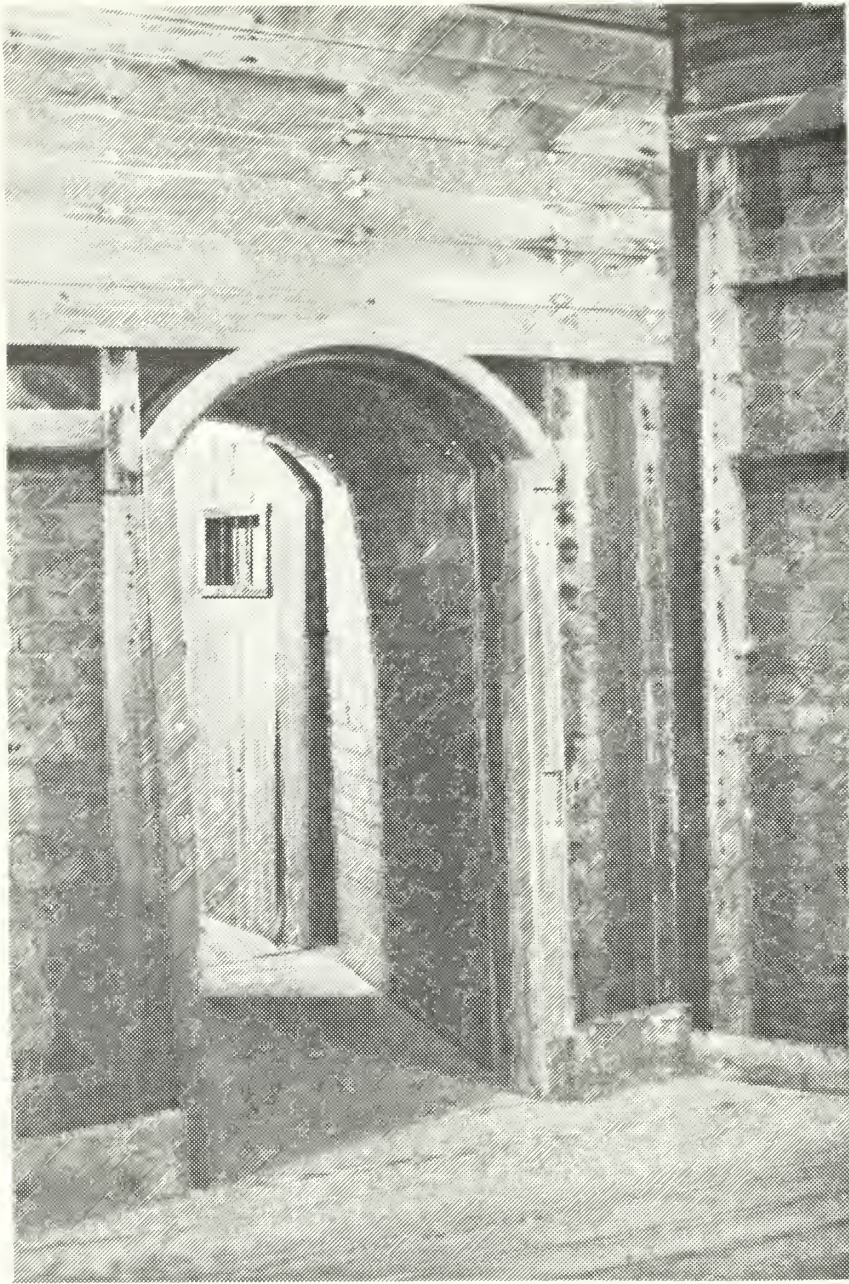
**Figure 5**

fort incorporated wood. Of what remains, the most visible situations in which wood is used are the magazines located in the centers of the long fronts on the lower tier and the tower bastion magazines. Typically, nominal 1-inch sheathing was installed over a frame of 3x4's, 18 inches on center. Wooden doors and doorframes of a very high level of craftsmanship are also evident in several areas of the fort. (See Figure 5, Wood-Lined Bastion Magazine. This photo was made in the magazine at Tower Bastion 1.)

WOOD-LINED BASTION MAGAZINE

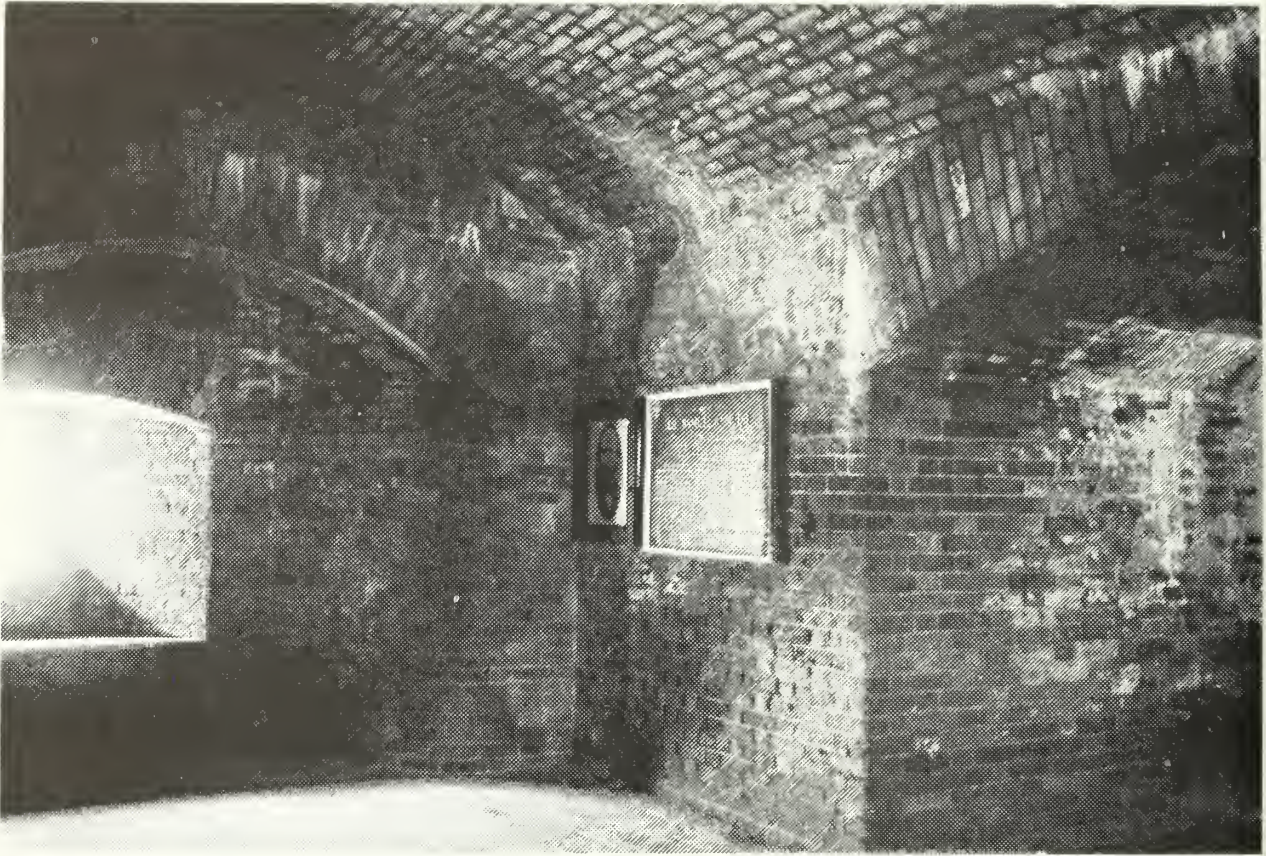
**Figure 11 PRESENT CONDITION**

Dr. Samuel Mudd's Cell, presumed to have been in the lower tier of Bastion 1, is currently in use as an interpretive feature of the fort. It is located near the terminus of the tour route upon descent from the terreplein. There are presently no conditions in this area which demand treatment or detract from its current use. (See Figure 11, Dr. Samuel Mudd's Cell.)

DR. SAMUEL MUDD'S CELL

Maintaining Dr. Mudd's cell for continued use as an interpretive feature of the fort is recommended.

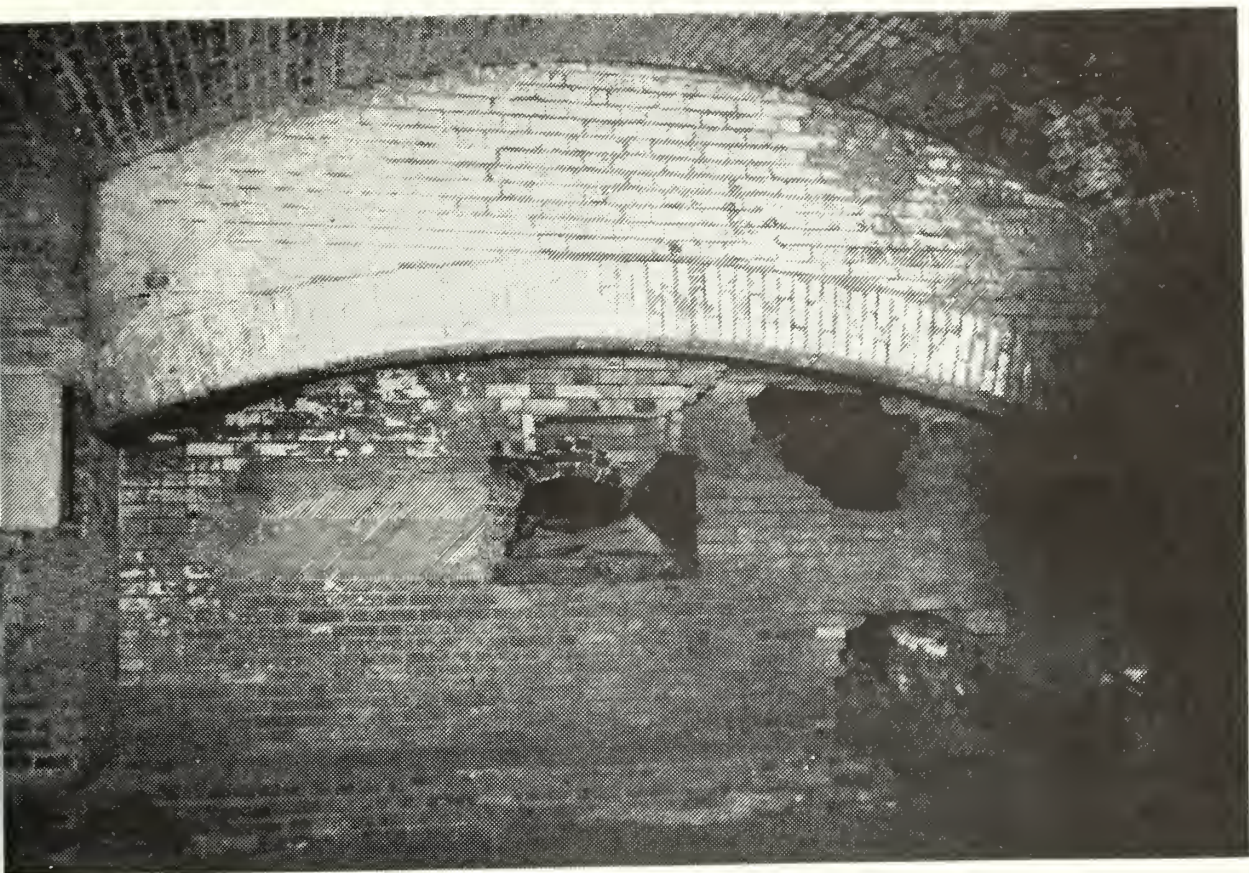
**Figure 15      PRESENT CONDITION**

The bakery, located in Bastion 3 of the lower tier, is an important interpretive feature of the fort and an element of the tour route. (See Figure 15, Bakery.)

BAKERY

The bakery is a similarly significant element of the fort's interpretive components. Like the shot furnace, the bakery is in need of repairs which could be coordinated with a recording project. In addition, the design of a timed lighting system, perhaps battery powered so as to avoid conduit installation, would provide illumination levels that could contribute much to an improved visitor experience of this feature. The possibility of implementing some or all of these measures merits further study.

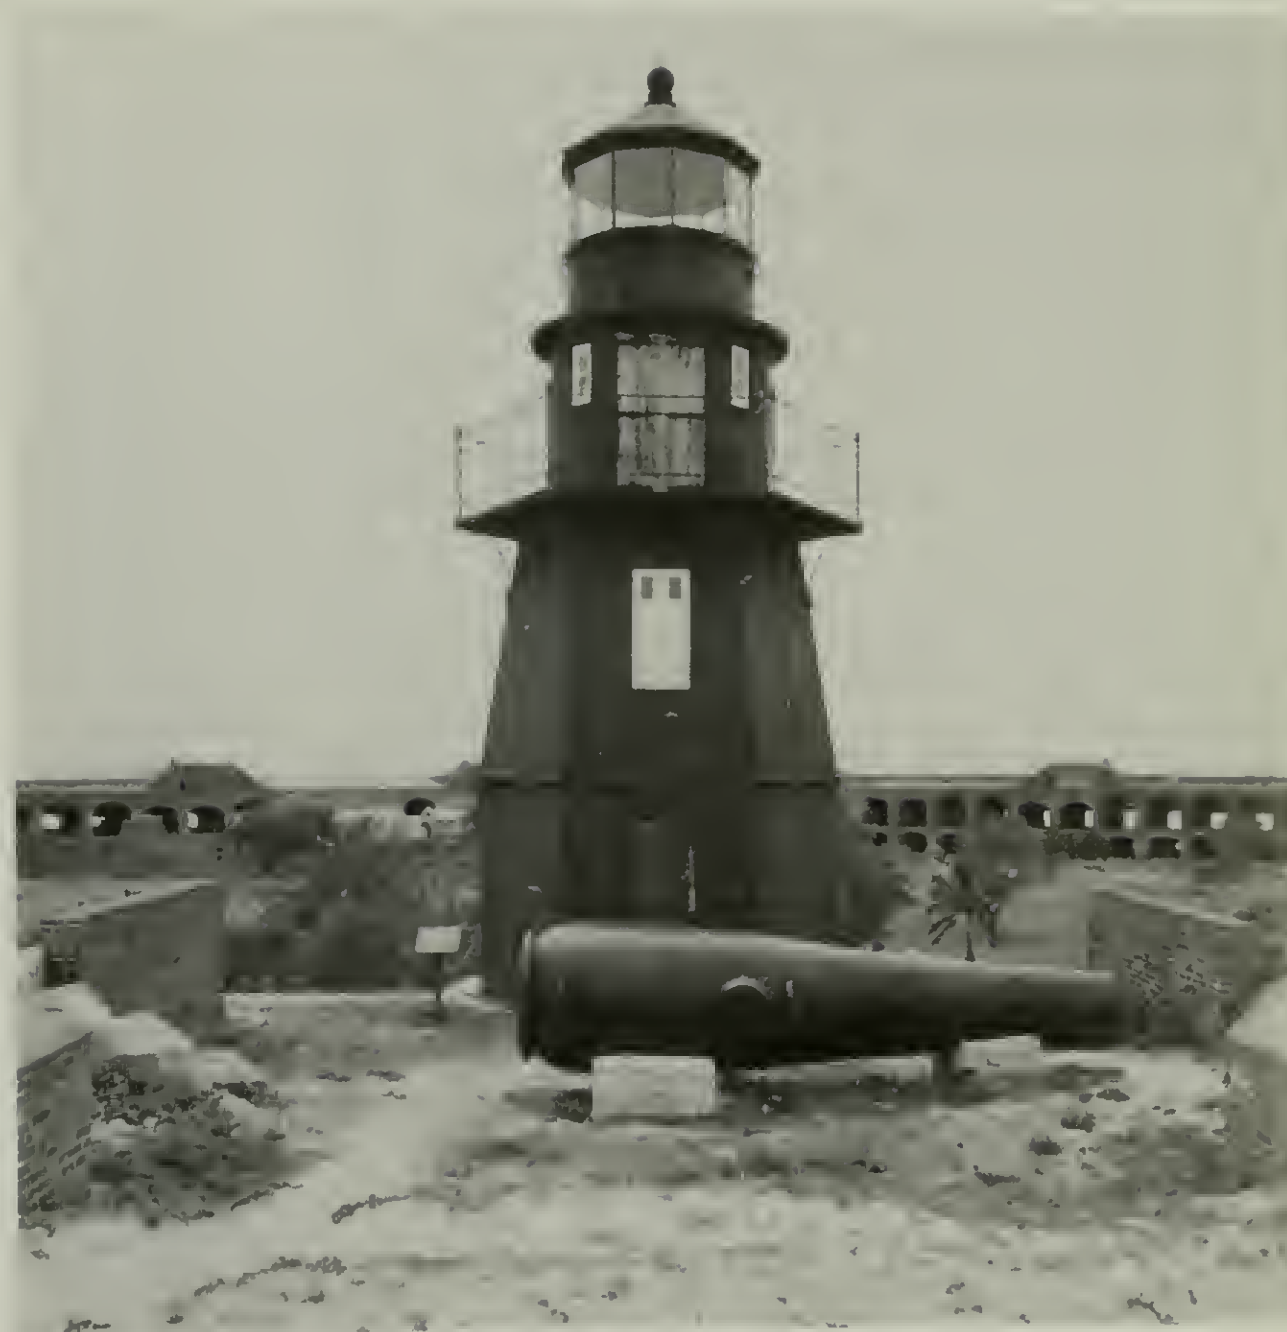
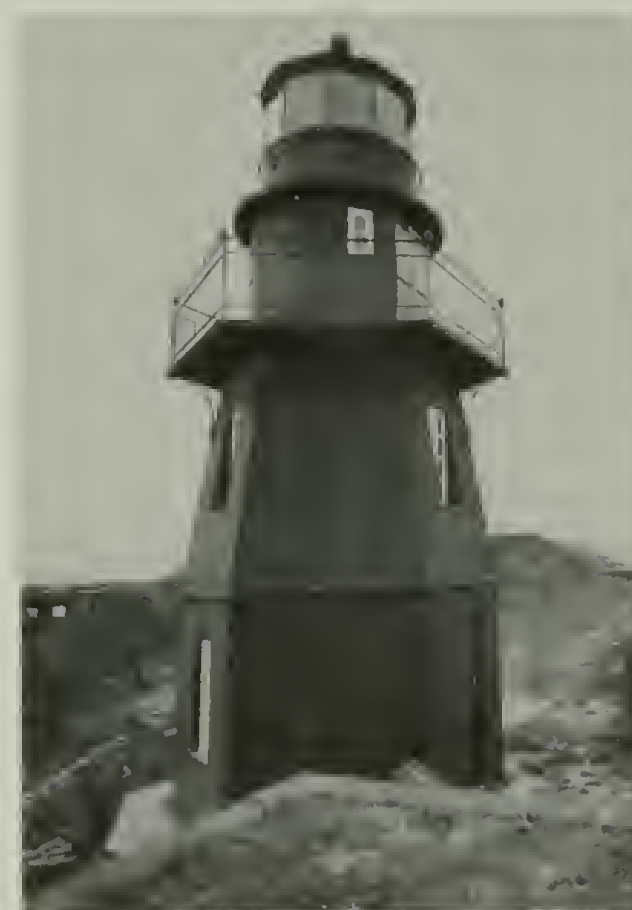
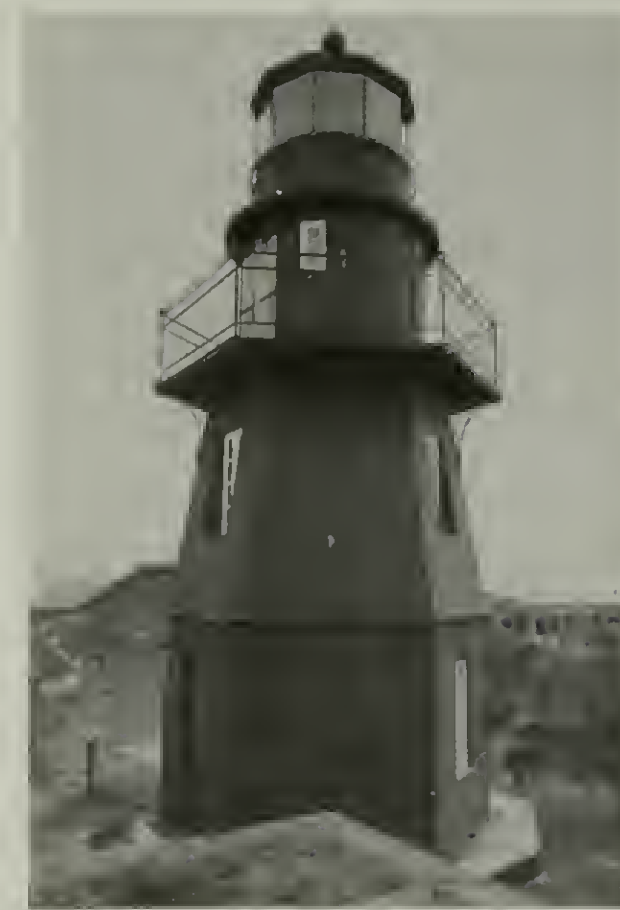
PRESERVATION MAINTENANCE WAS PERFORMED ON THE LIGHTHOUSE IN JULY, 1983. MAJOR ELEMENTS OF THIS WORK INCLUDED: SANDBLAST CLEANING AND REPAINTING THE EXTERIOR, REPLACING ALL LANTERN GLASS, REPAINTING THE LIGHTHOUSE INTERIOR, REPLACEMENT OF DOOR AND WINDOW HARDWARE AND REPAINTING AND REFINISHING LIGHTHOUSE DOORS AND WINDOWS. ELEVATIONS SHOW EXISTING CONDITIONS PRIOR TO ABOVE WORK.

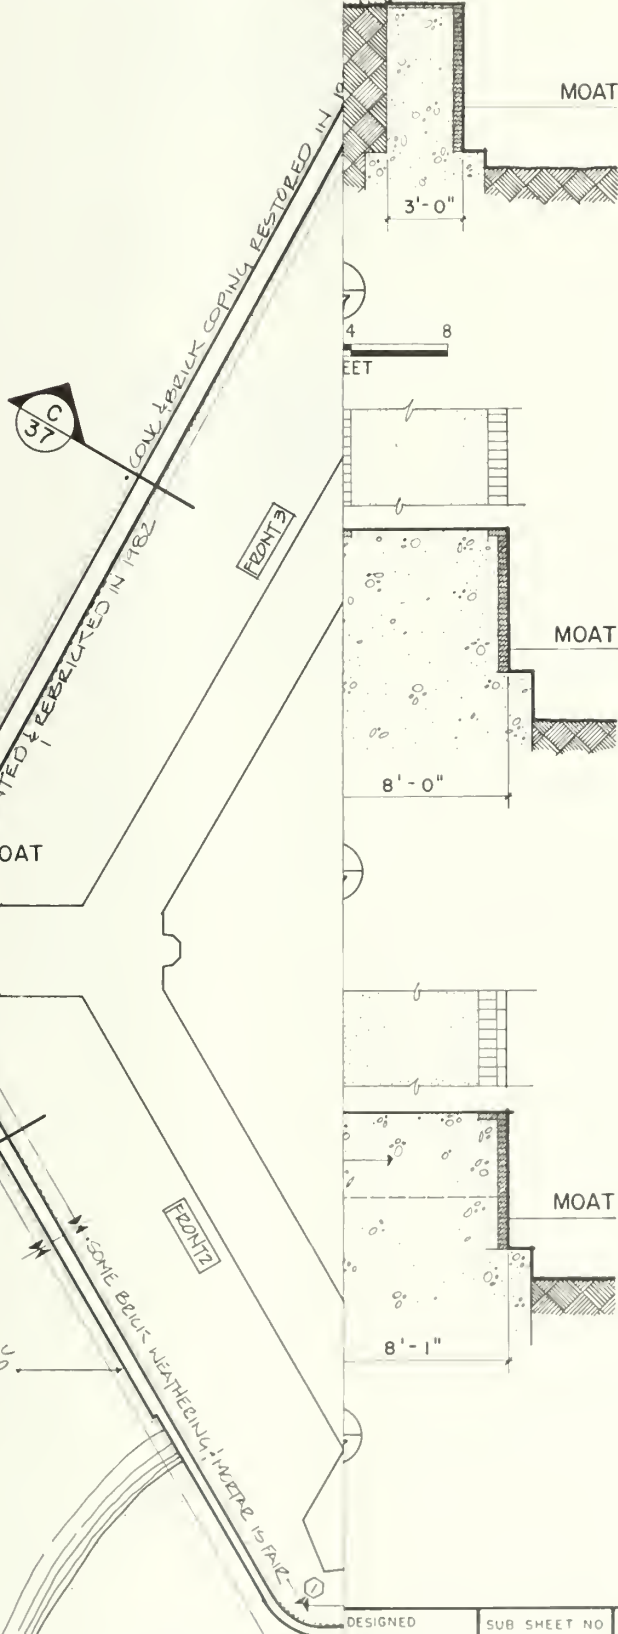
SECTION B  
SCALE: 1/4"=1'-0" 37

NOTE: NOTES OUTSIDE OF  
MOAT REFER TO EXISTING CONDITION  
OF COUNTERSCARP COPING.

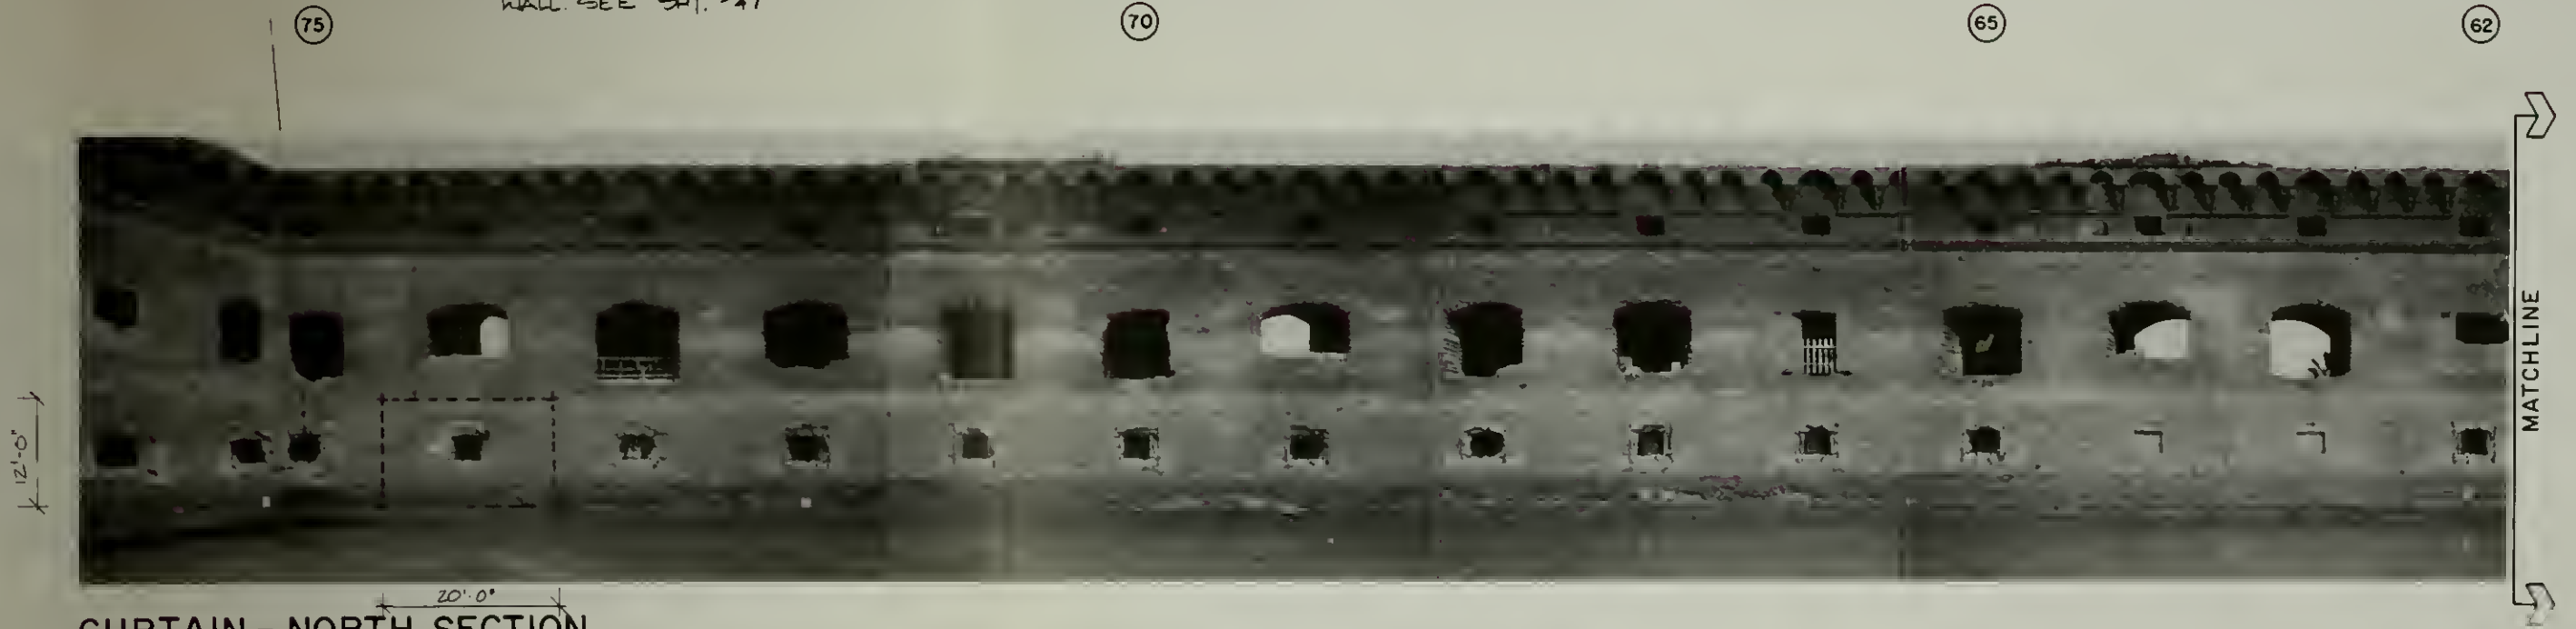
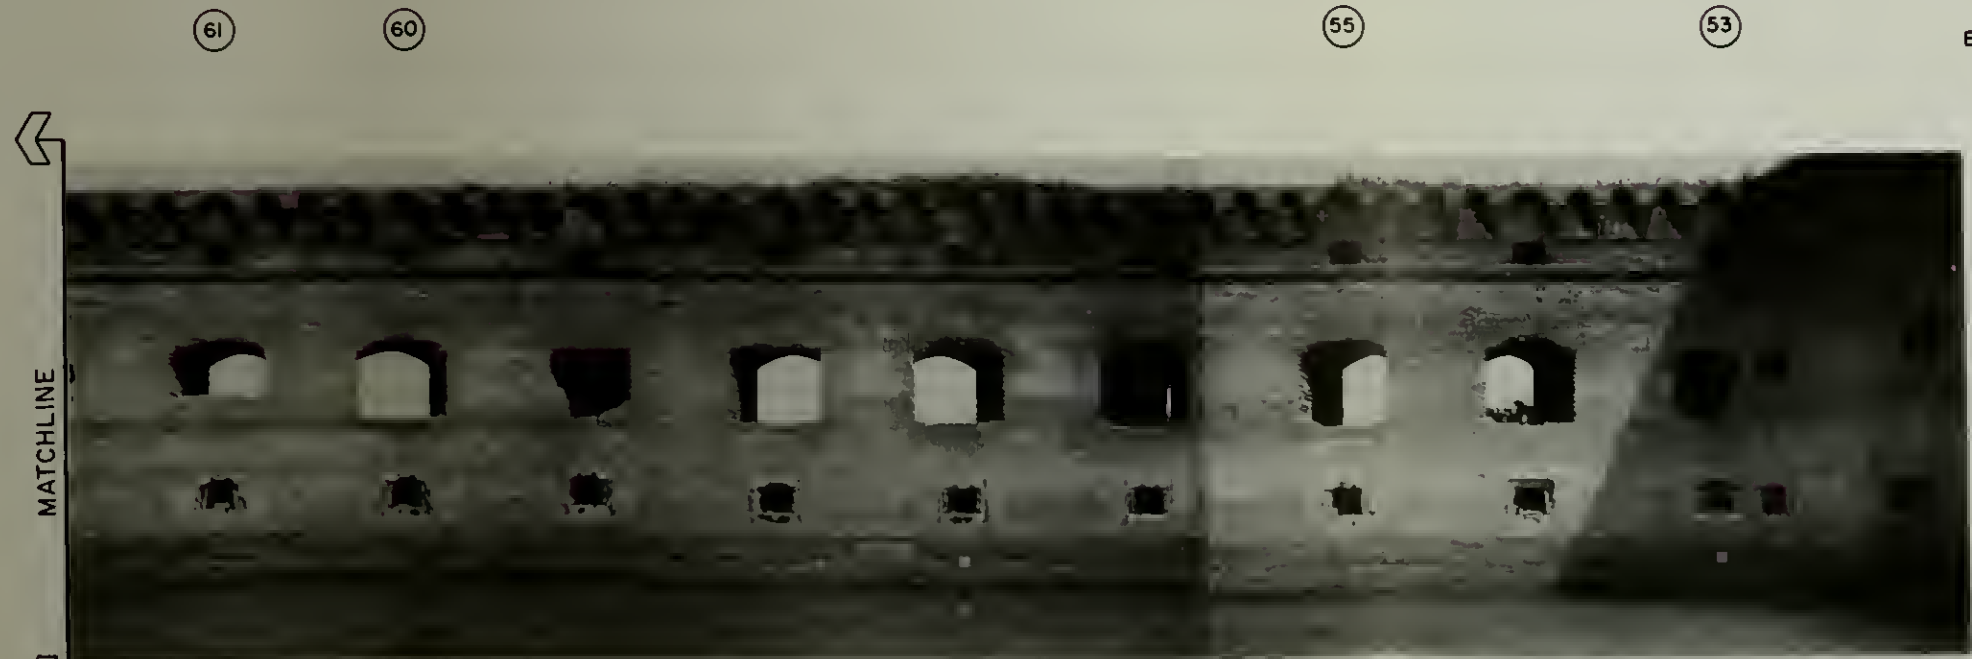
**CURTAIN - NORTH SECTION**

LOWER TIER EMBRASURE #75 WAS EXPERIMENTALLY STABILIZED IN 1983. INSTALL COR-TEN STEEL "SILHOUTTE" PLATE TYPICAL FOR STABILIZED EMBRASURES SEE SHT # 47

STABILIZE LOWER TIER EMBRASURE #74 REPAIR, REPOINT: 240 SQ. FT. OF CURTAIN WALL. SEE SHT. #47

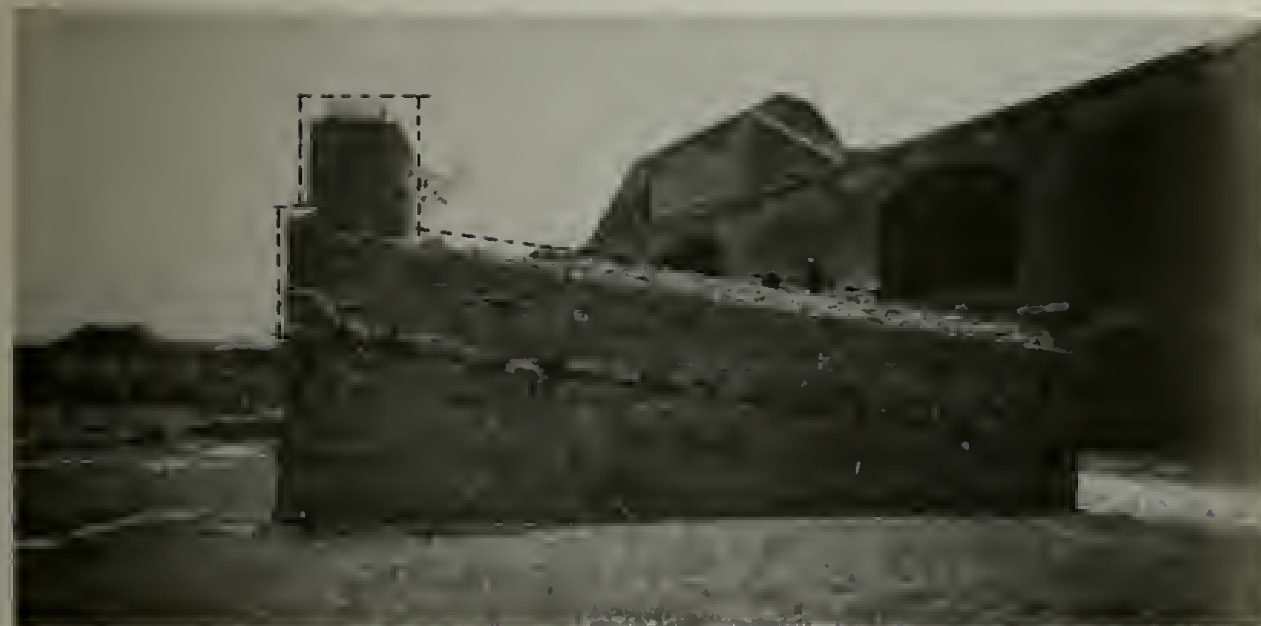
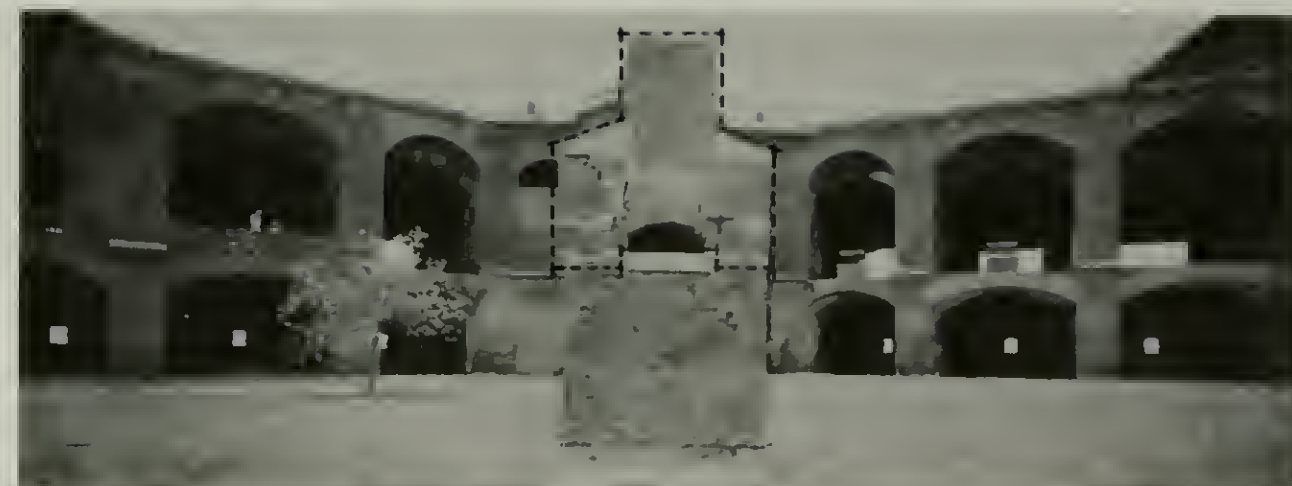
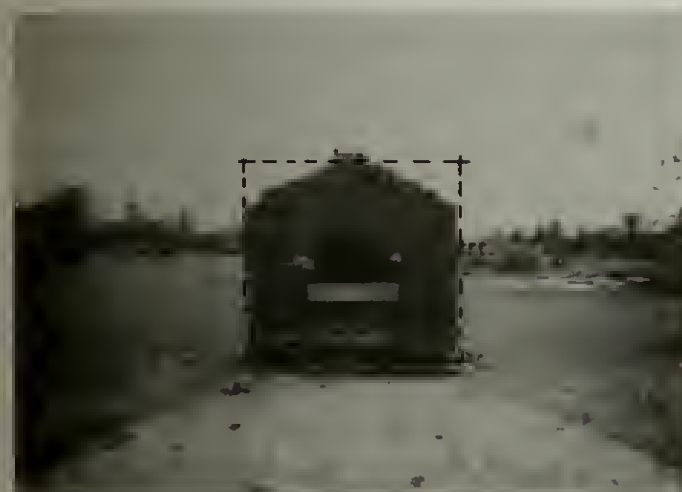
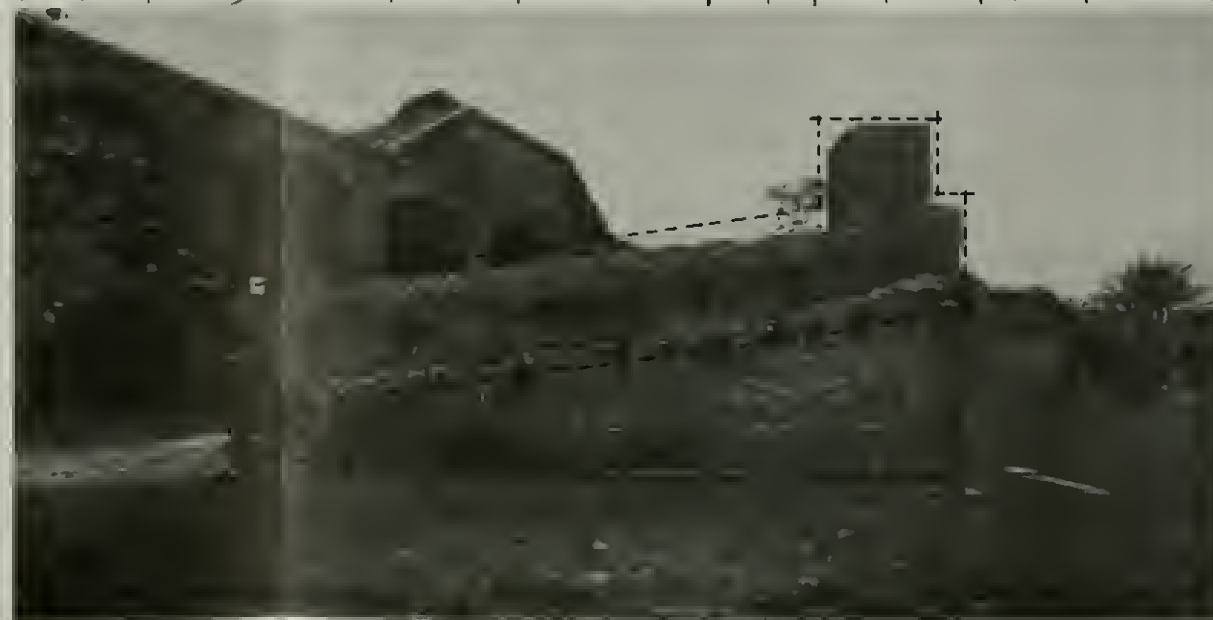
DESIGNED MCGRATH	SUB SHEET NO.	TITLE OF SHEET SHOT FURNACE RESTORATION	DRAWING NO 364
DRAWN ANDERSON		PROPOSED WORK HISTORIC STRUCTURE REPORT	25,000A
TECH. REVIEW THORSON			PKG. NO. 103
DATE 10/1/84			SHEET 47
			OF 47

HISTORIC DRAWINGS FOR THE SHOT FURNACE HAVE NOT BEEN LOCATED, THEREFORE INTERIOR DETAILS OF THIS STRUCTURE ARE UNKNOWN. THE AREAS WITHIN THE DASHED LINES ARE SEVERELY DETERIORATED AND WILL REQUIRE A MAJOR INTERVENTION TO SAVE THIS STRUCTURE. ANTICIPATED WORK WOULD INCLUDE: CAREFUL DEMANTLING OF ALL AREAS WITHIN DASHED LINES, RECORDING OF EXPOSED DETAILS, REMOVAL OF EXFOLIATED IRON, TREATMENT AND/OR REPLACEMENT OF THE HISTORIC IRON FRAM, REBUILDING DEMANTLED AREAS; WATERPROOF DETAILING CORAL RUBBLE FURNACE TOP.

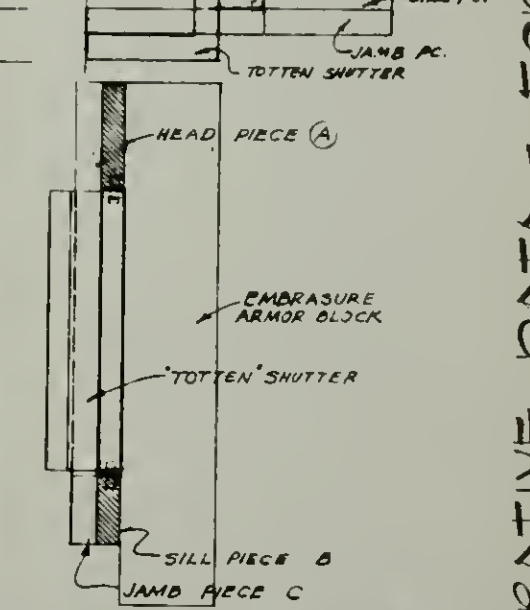
• SECTION @ E OF EMBRASURE •  
SCALE: 1 1/2" = 1'-0"

NOTE TO DATE NO BOLT STRIKES HAVE BEEN FOUND; LOOSE OR IN PLACE DETAIL TAKEN FROM ORIGINAL PLANS, (SHEET 22) FILED IN DRAWER 75, # 91 H.S.E.  
NOTE ON 17 FEB 1976 ONE LOCATED ON NORTH FACE ALL DIMENSIONS AGREE WITH DETAIL ON ORIGINAL DWG H.S.E.
